Report No. 0809-25224

**SNAPPER™ REMOTE CONTROL
BOAT LATCH EVALUATION**

Philip Dindinger P.E.

October 29,2008

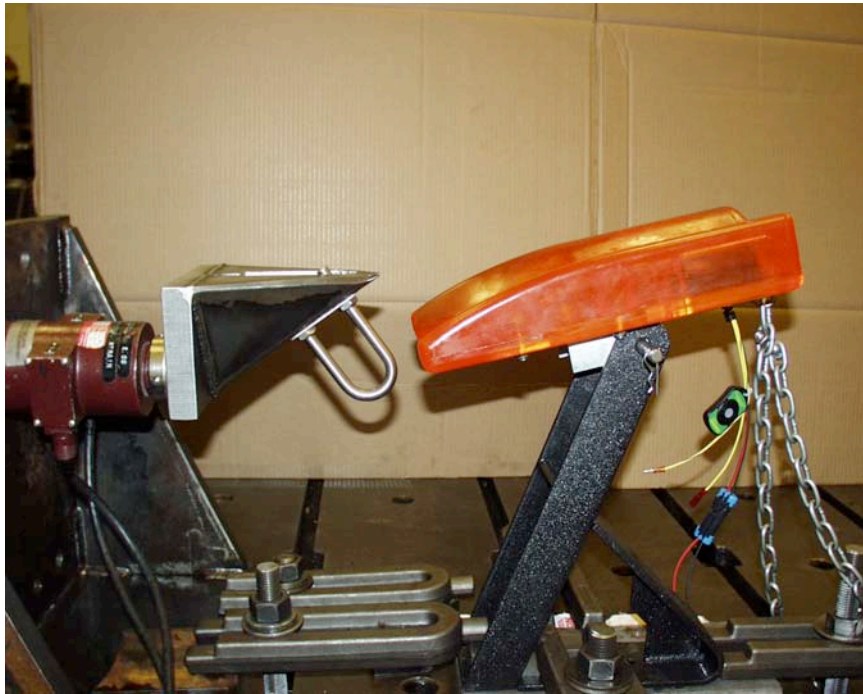
Fig. 1 - Overall side view of test setup.

Special fixtures were designed and fabricated that simulated a boat trailer installation and the bow of a boat. The SNAPPER was mounted to a typical trailer winch stand which was rigidly clamped to a bedplate. The simulated boat bow had a ½" diameter X 3 ½" stainless steel extended bow eye installed at an included angle of 100 degrees and was positioned at an angle of 35 degrees to the horizontal. The simulated boat bow was rigidly mounted to a hydraulic actuator that provided the loading. The test setup is included as Fig. 1 and 2.

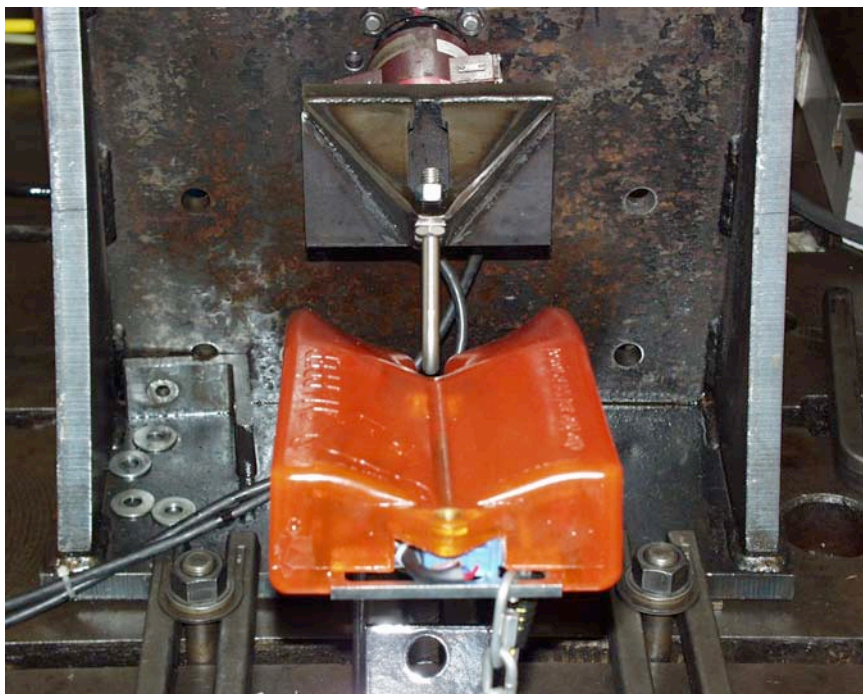
Fig. 2 - Overall Front view of test setup.

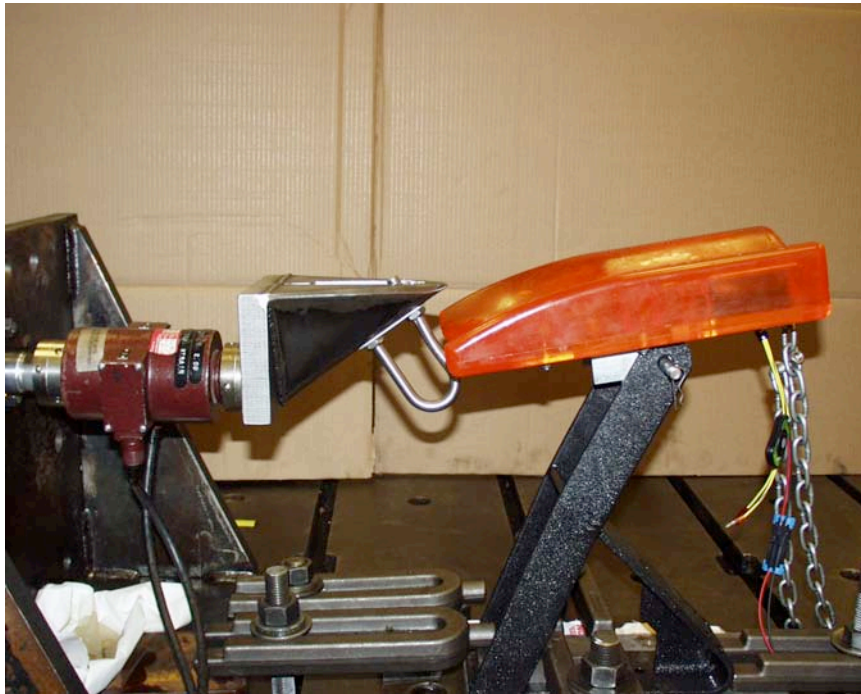
- The mounting bracket was dented slightly more than from the initial loading. (Fig. 5 & 6)
- The bow eye was slightly bent from contact with the SNAPPER after all of the loadings. (Fig. 3 & 4)
- The winch stand upright supports were also bent. (Fig. 7)

Fig. 3 - Overall view of bent bow eye after loading and contact with the SNAPPER mounting plate.

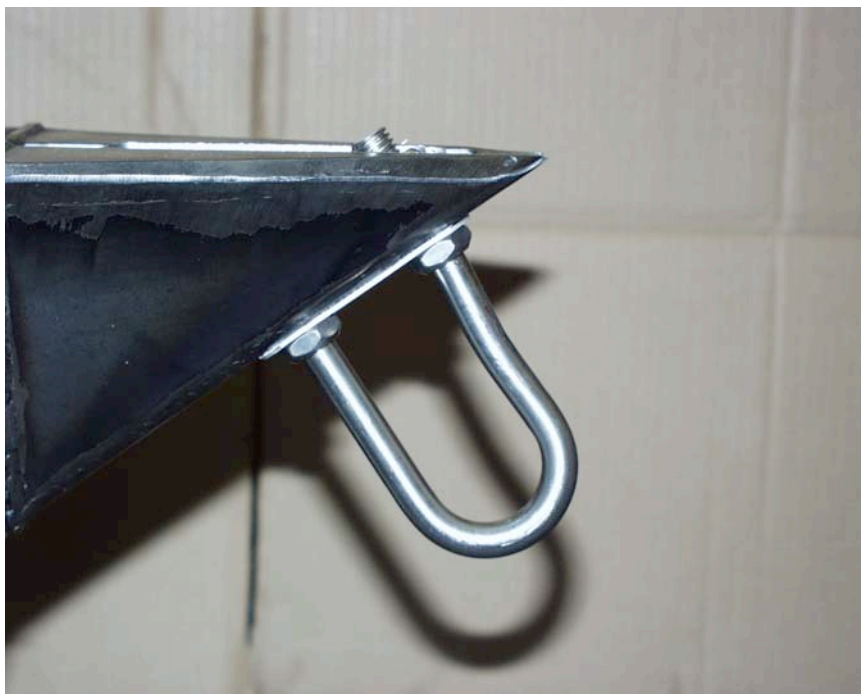
Fig. 4 - Bent bow eye after loading and contact with the SNAPPER mounting plate.

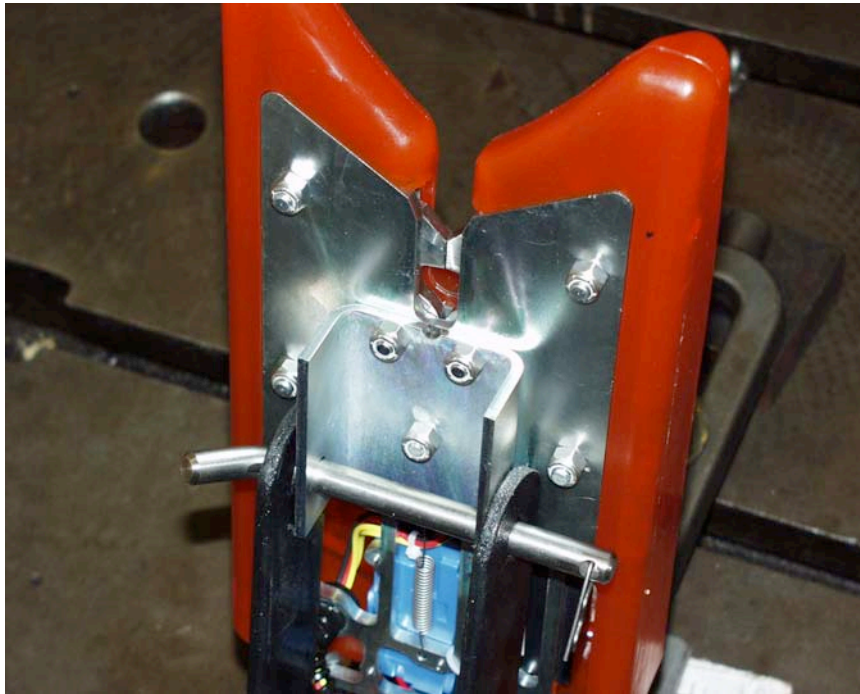
- There was slight denting of the mounting bracket where the bow eye contacted it. (Fig. 5 & 6)
- The bow eye did not appear to be bent.

Fig. 5 - Overall view of denting of the SNAPPER mounting plate from contact with the bow eye.

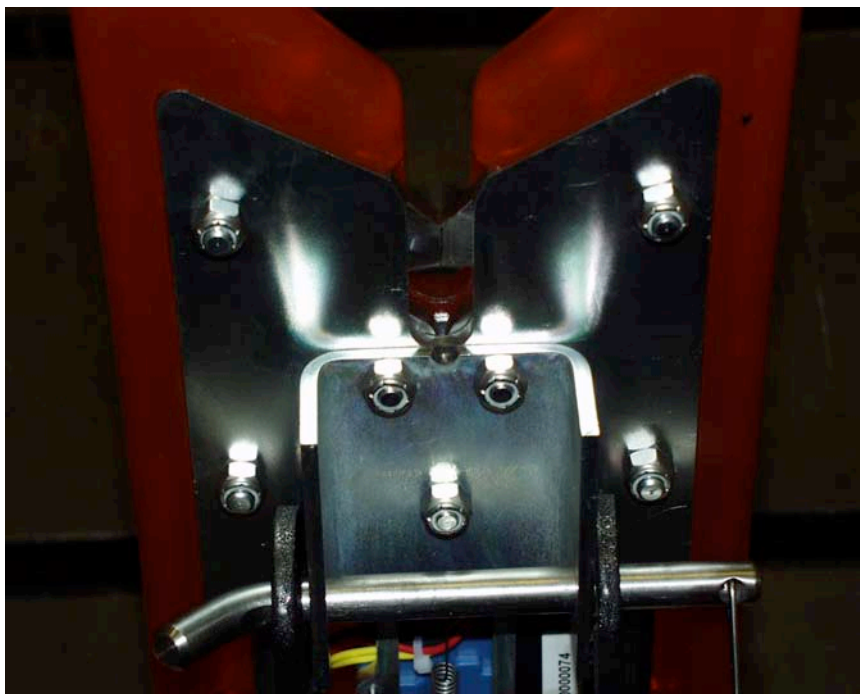
Fig. 6 - Close up view of denting of the SNAPPER mounting plate from contact with the bow eye.

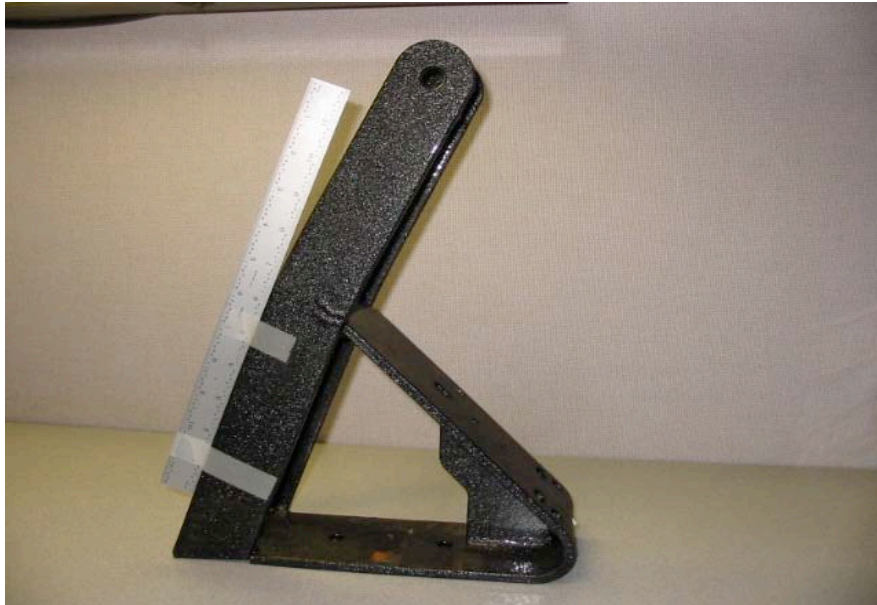
Fig. 7 - Bent winch stand upright supports after loading.
